BrR FOR BRIDGE MAINTENANCE & REHABILITATION

FORSGREN ASSOCIATES, INC.

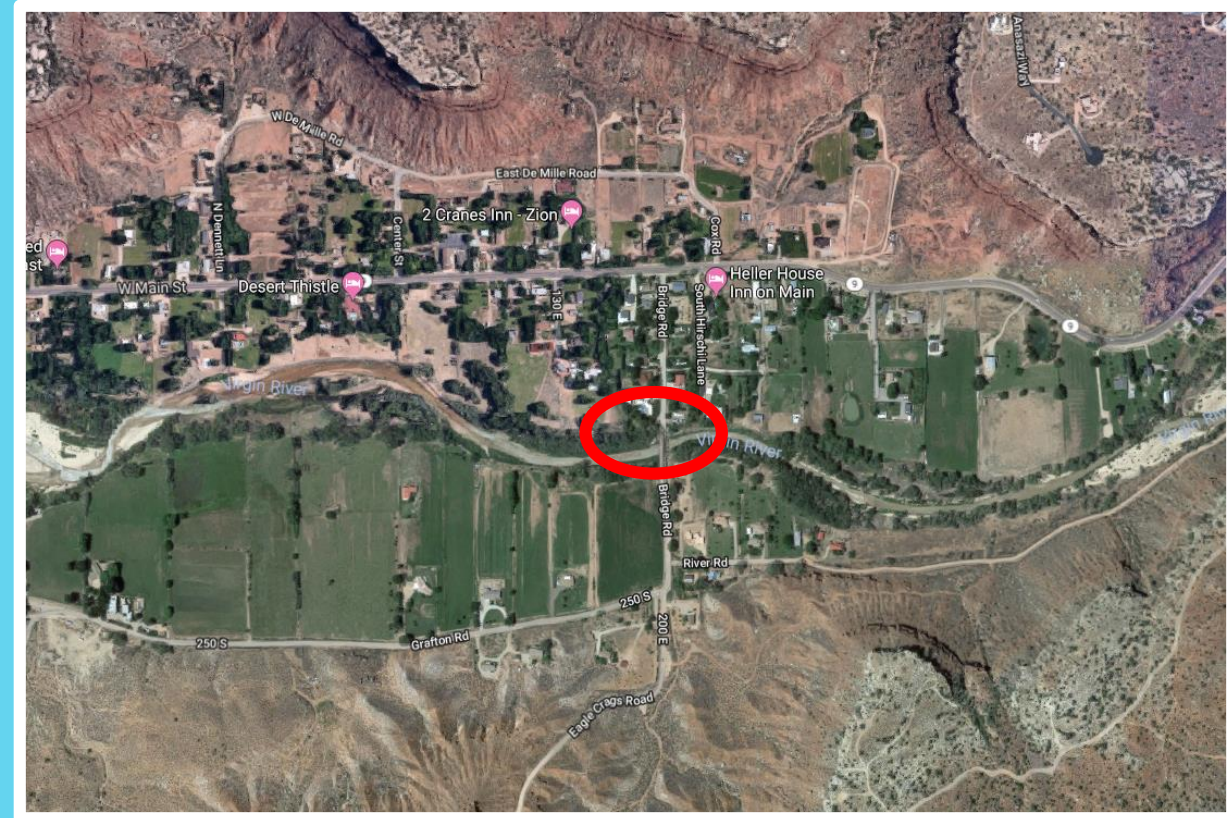
ROCKVILLE TRUSS, ROCKVILLE, UT

- ▶ 220 ft Steel through truss bridge built in 1924
- ▶ Only access from Rockville to farms and residences south of the Virgin River
- ▶ Detour Length of over 40 miles
- ▶ Bridge Closure would have a severe impact
- ▶ Initial rating of 0

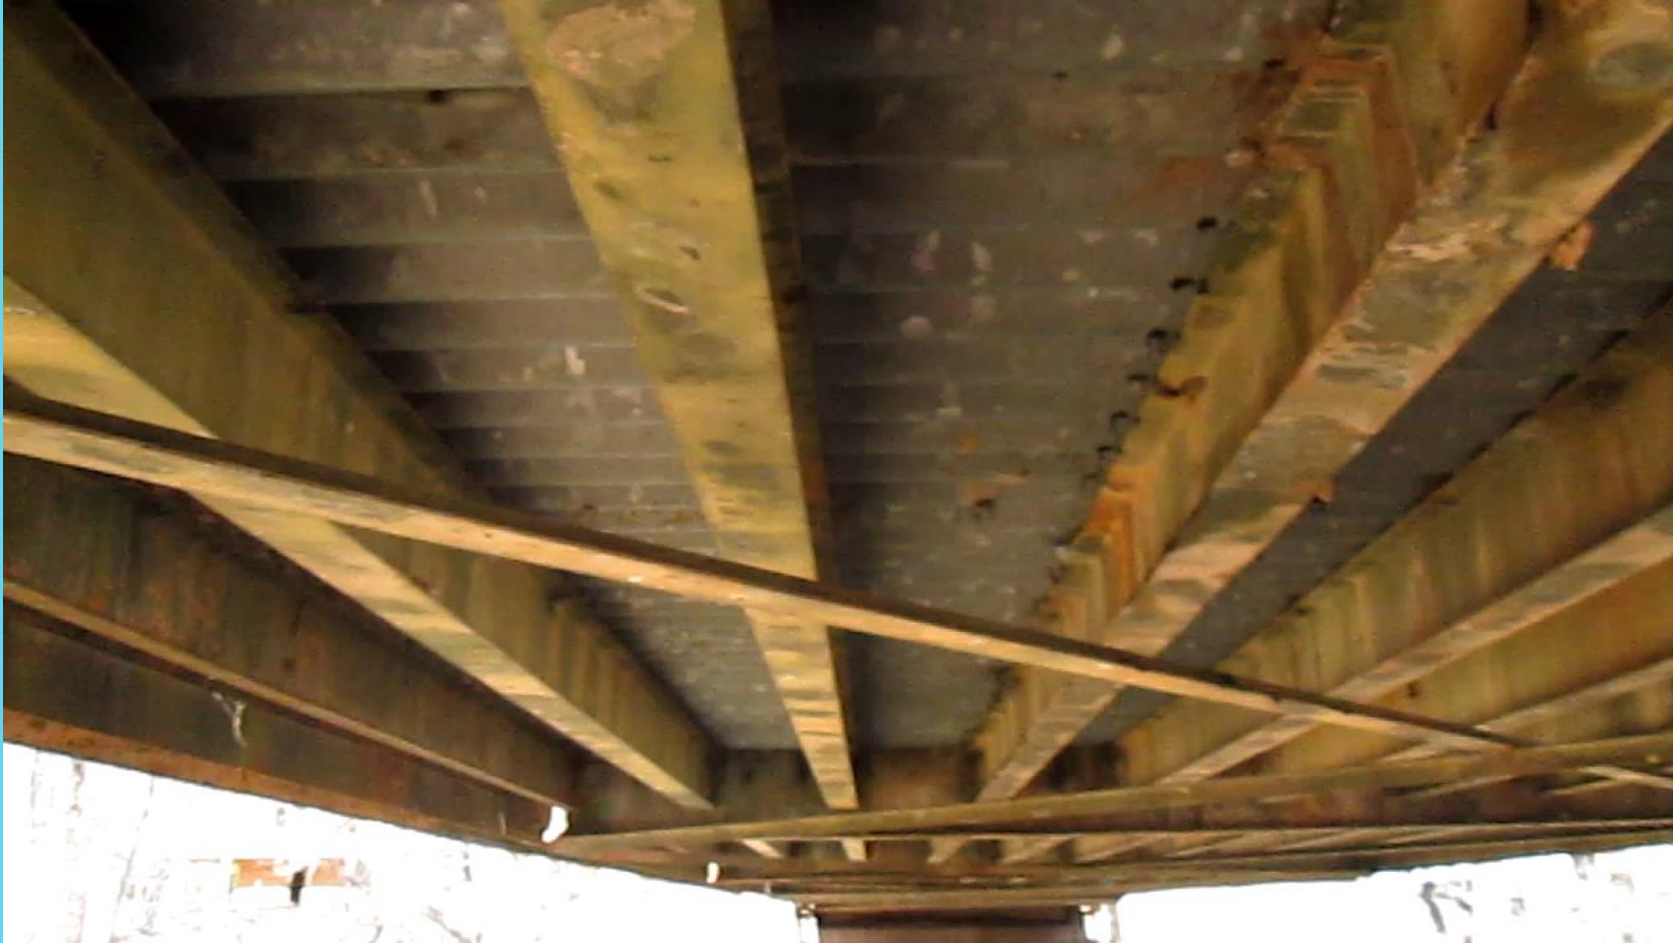
ROCKVILLE TRUSS, ROCKVILLE, UT

- ▶ Looked for alternatives to refine the load rating
- ▶ Obtained additional field measurements allowed a reduction in the wearing surface thickness
- ▶ Analyzed vehicles in the middle 12 ft
- ▶ Low ratings from multiple bridge components = strengthening would be a major task
- ▶ Model revisions allowed the bridge to remain open with load posting

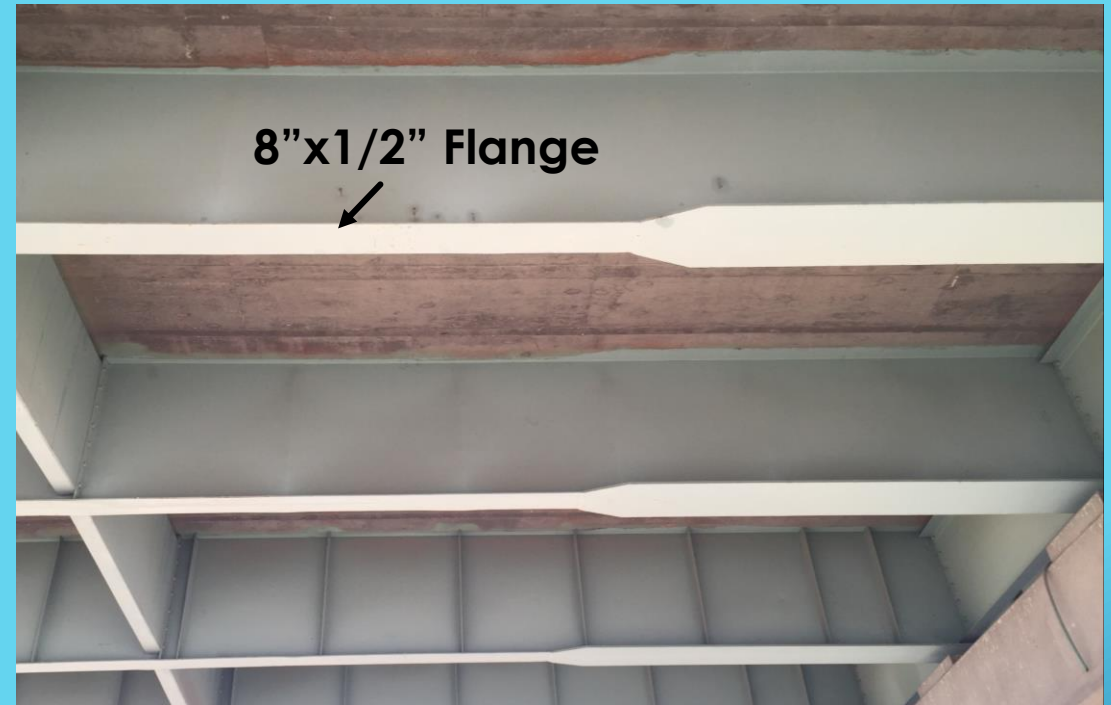
16TH AVENUE OVERPASS, NAMPA, ID

- ▶ BrR Spec Check showed the bottom flange in compression after the transition to the 8"x1/2" flange
- ▶ With the current diaphragm spacing of 22.75 ft the unbraced length was too long
- ▶ Looked at several options including
 - ▶ Cover plate
 - ▶ Longitudinal stiffener near bottom flange
 - ▶ Additional diaphragms near flange transitions

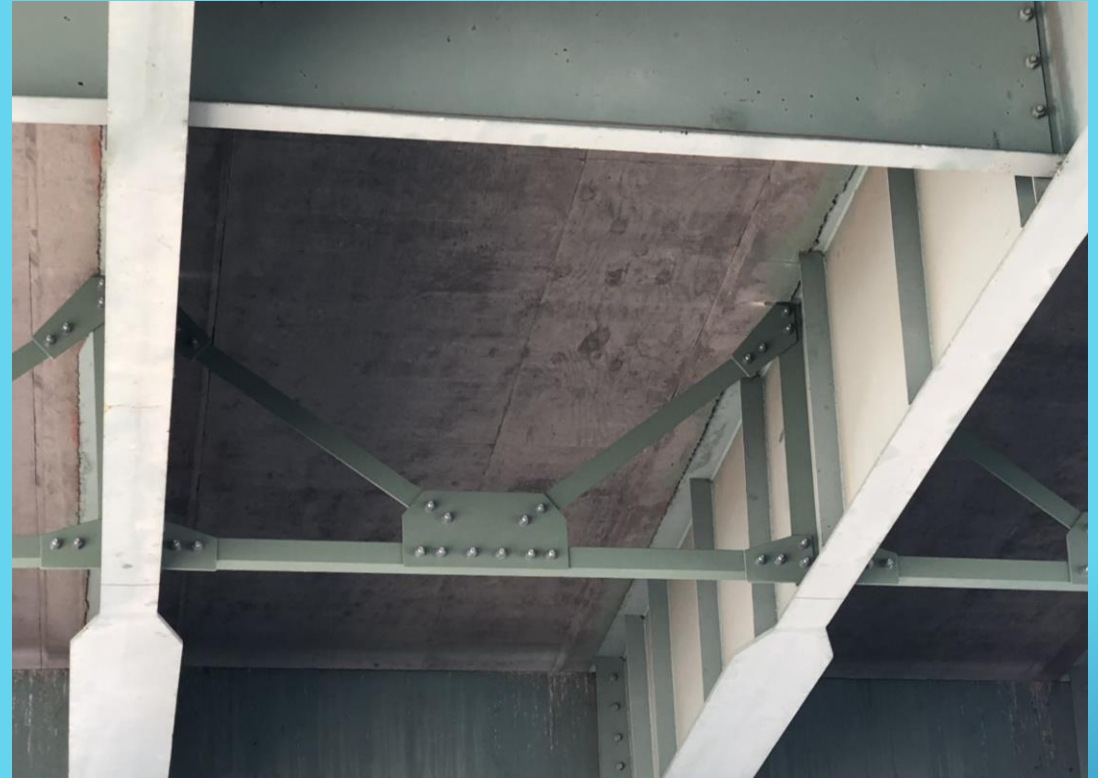
16TH AVENUE OVERPASS, NAMPA, ID

- ▶ Chose to add diaphragms near each flange transitions
- ▶ This option was the least expensive and easiest to construct in the field
- ▶ The City was able to remove the posting and open the bridge to full legal loads

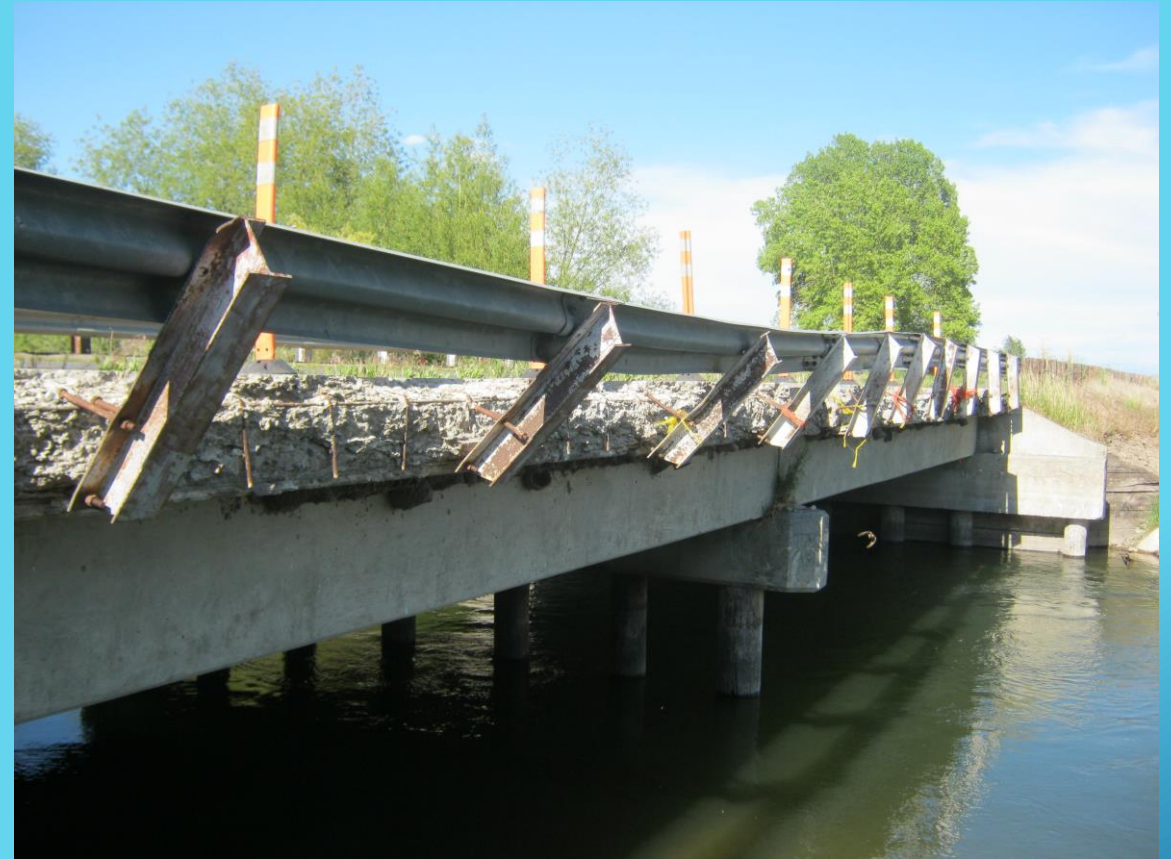
MOODY RD BRIDGE, MADISON COUNTY, ID

- ▶ RCT bridge built in 1959
- ▶ Severe concrete deterioration at edge of deck and curb
- ▶ Used BrR to verify bridge capacity warranted repair

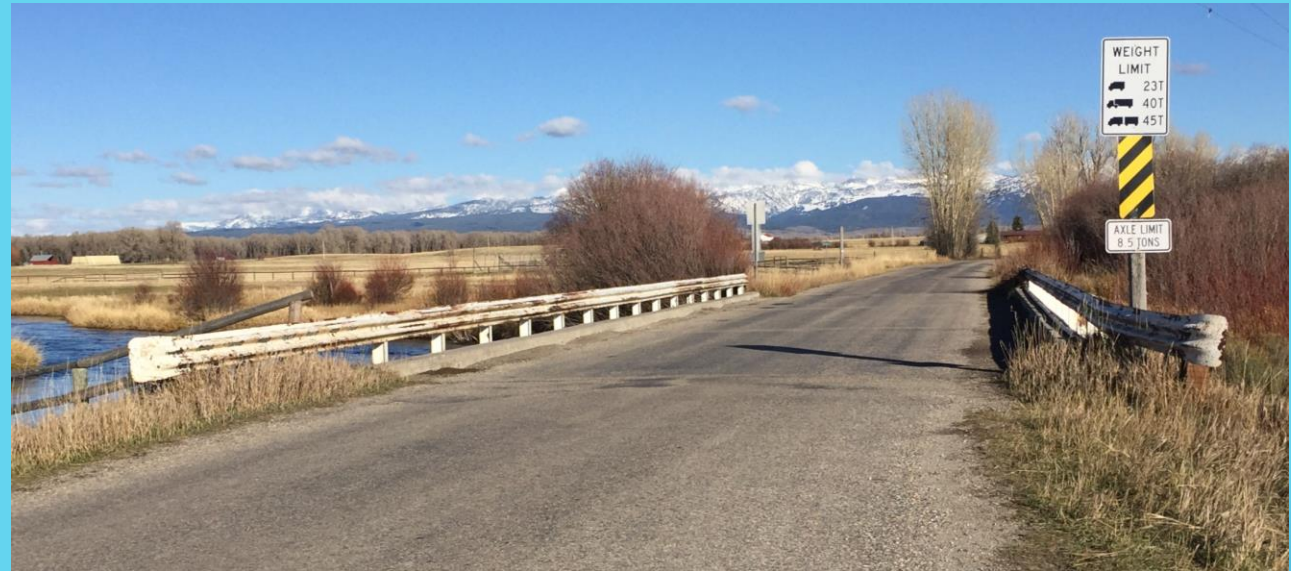
PACKSADDLE RD BRIDGE, TETON COUNTY, ID

- ▶ 3-Span RCT bridge built in 1956
- ▶ Scour concerns, concrete deterioration at pier caps and substandard rails
- ▶ Currently load restricted
- ▶ Developed BrR model to evaluate rehabilitation vs. replacement
